## OPERATIONAL SAFETY NOTICE

### Rolls-Royce M250 Engines: Maintenance Warning – External Lines

# ALERT COMMERCIAL SERVICE LETTER

## MAINTENANCE WARNING - EXTERNAL LINES

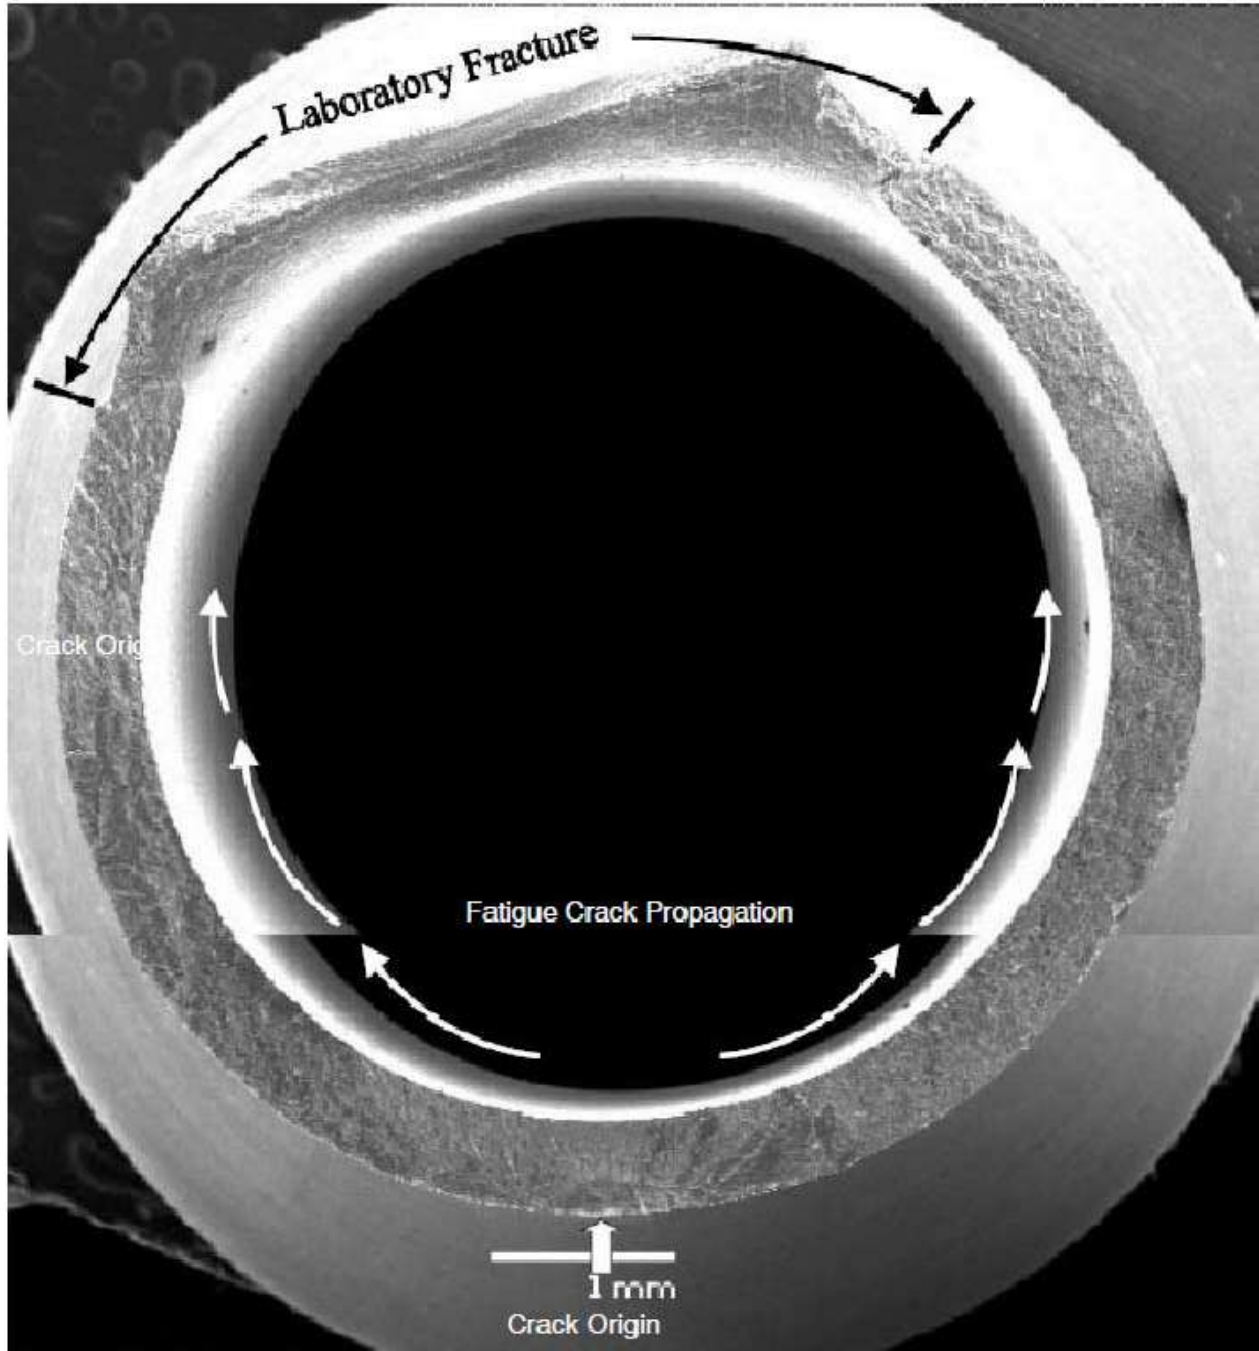
FIG. 3

- A. The tube is bent in an area that is not a principal bend, a region that should be straight. See [Figure 1](#).
- B. Severe fretting was found under the ferrule sleeve caused by misalignment of the tube to fitting joint. See [Figure 2](#).
- C. The flared tube was found cracked 270° circumferentially in the area of ferrule fretting. The crack and fretting were likely caused by misalignment of the tube to fitting joint. See [Figure 3](#).

Tube Assembly, P/N 6890581 Surface of Fracture

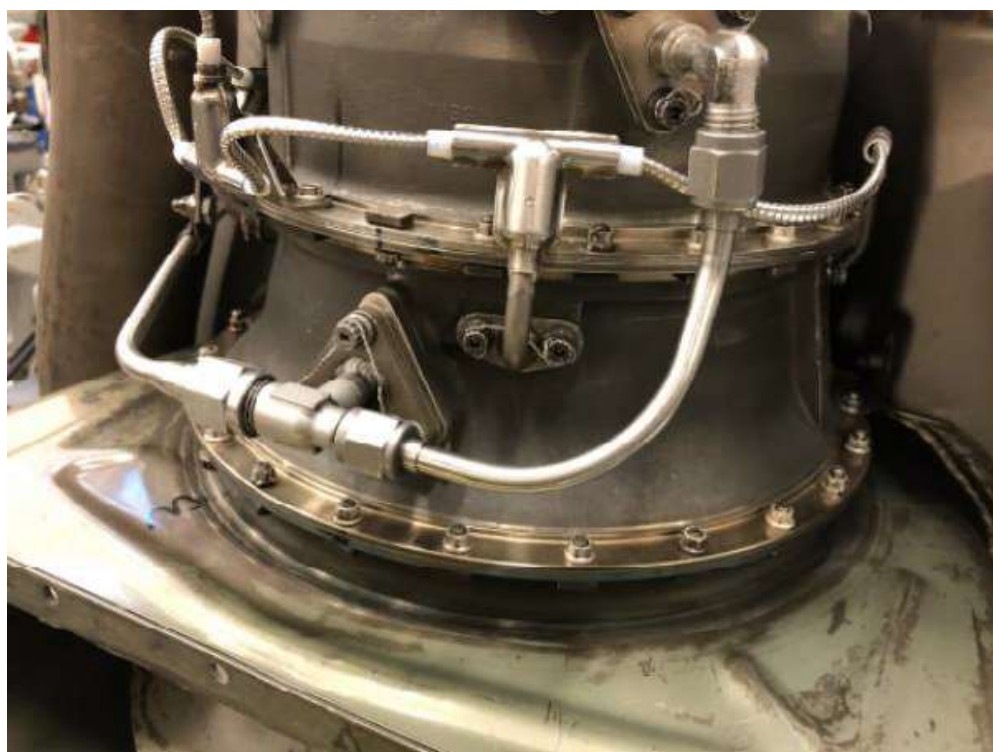
Incorrect Installation  
FIG. 12B
